DETECTION OF WATER LEAKS IN THE OUIZERT DAM BY THE TEMPERATURE METHOD

BENFETTA H.^{1}, ACHOUR B.², REMINI B.³, OUADJA A.⁴*

ABSTRACT

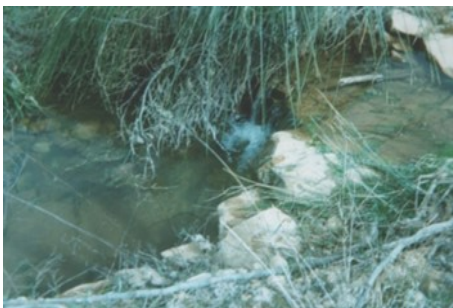
Photograph 2: Water leaks on the left bank next to the SB13 piezometer at Ouizert Dam (Benfetta, 2018)

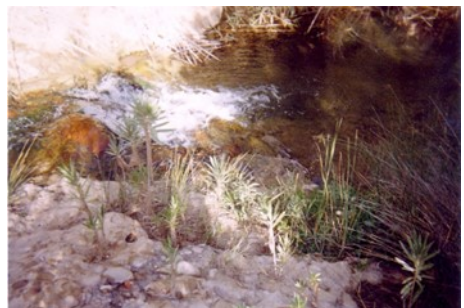
Photograph 3: Meeting of the three Water Leaks on the left bank below the Ouizert Dam (Benfetta, 2018).

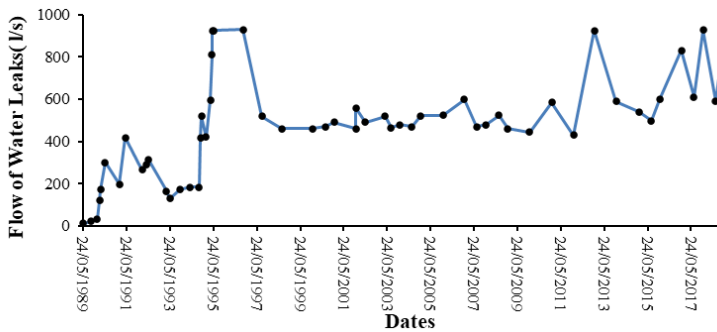
Figure 3: Variation in the leakage rate of the Algerian dam of Ouizert

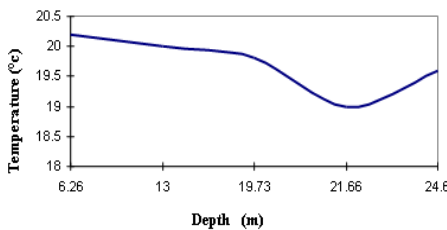
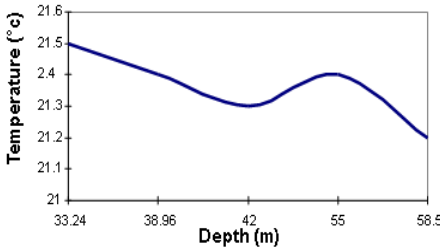
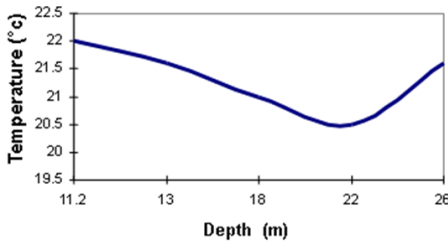
Figure 4: Graphical representation of temperature as a function of depth -SB13- left bank

Figure 6: Graphical representation of temperature as a function of depth–SB5-left bank

Figure 8: Graphical representation of temperature as a function of depth –SB12-left bank

Figs. 4 to 9 illustrate well the disturbances and temperature anomalies caused by infiltration and the existence of leaks and indicate the different areas where water infiltrates. The recognized infiltrations result from the degraded state of the geological layers crossed by these piezometers.

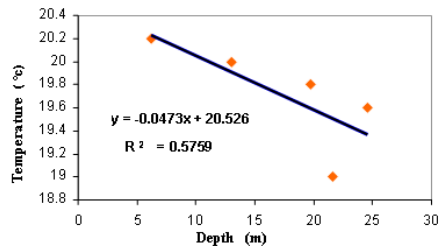
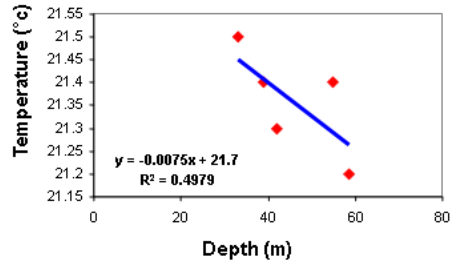
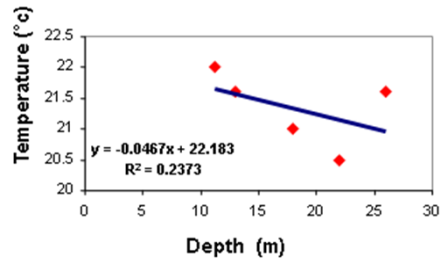
Figure 5: Graphical representation of temperature as a function of depth -SB13- left bank

Figure 7: Graphical representation of temperature as a function of depth –SB5--left bank

Figure 9: Graphical representation of temperature as a function of depth –SB12-left bank

In Figs. 5, 7 and 9, we obtained very small correlation coefficients (0.57, 0.49, 0.23), which explains that there is no relationship between the two parameters and that there is a disturbance in the temperatures at each depth level. This means that there is a high water circulation and disturbance in the water circulation and the groundwater flow is not uniform and varies sharply. The infiltration of the retaining fluid through these layers causes temperature anomalies in its material. Figs. 4 to 9 illustrate well the disturbances and temperature anomalies caused by infiltration and the existence of leaks and indicate the different areas where water infiltrates. The recognized infiltrations result from the degraded state of the geological layers crossed by these piezometers (Benfetta and Oudja, 2018; Heinrich, 2001).

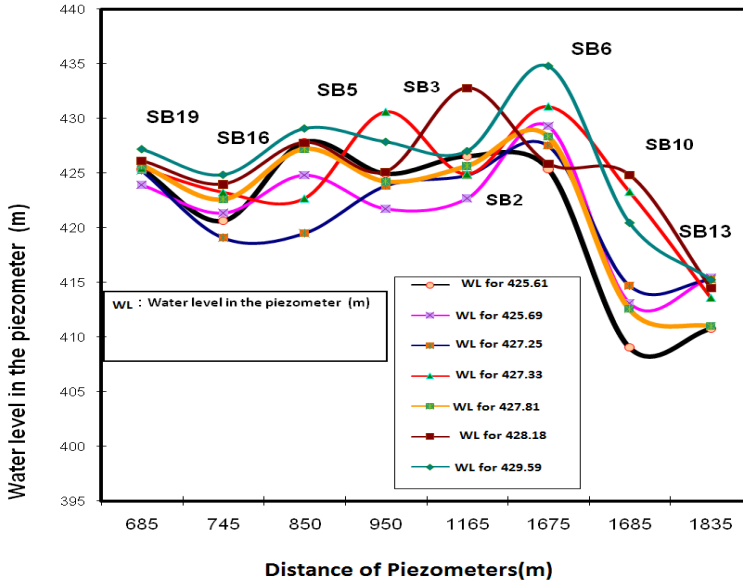
Figure 10: Piezometric variation as a function of lake level – left bank - Ouizert Dam

Fig. 10 shows that the current lines have a strong curvature, and the groundwater flow is not uniform and varies sharply, which means the presence of highly permeable geological layers due to the existence of cracks that present preferred routes for water leakage in the left bank of the dam (Benfetta and Ouadja, 2018; Heinrich, 2001).

Fig. 10 shows that the current lines have a strong curvature, and the groundwater flow is not uniform and varies sharply. This means the presence of highly permeable geological layers due to the existence of cracks that present preferred routes for water leakage in the left bank of the dam.

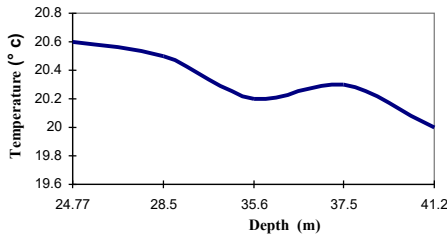
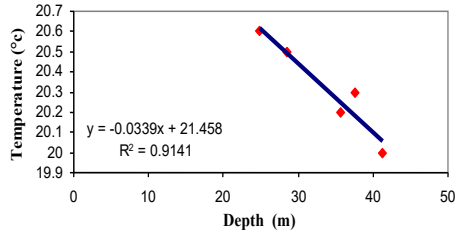
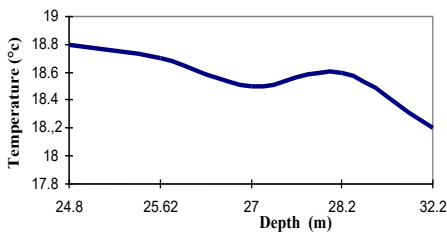
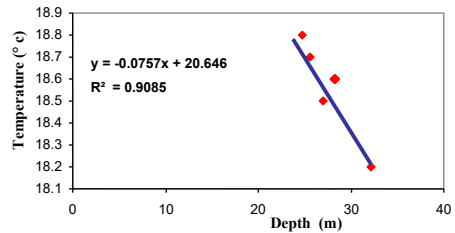
In Figs. 11 to 14, we obtained very high correlation coefficients (0.91, 0.90), which explains that there is a very good relationship between the two parameters and that there is stability in temperatures at each depth level. The groundwater flow is uniform and does not change abruptly. They show that there is a good correlation that tells us about the normality and stability of temperatures, thus confirming the absence of leaks and infiltrations in the body of the dike (Benfetta and Ouadja, 2018; Heinrich, 2001).

Figure 11: Graphical representation of temperature as a function of depth -PII(20)-Dike body

Figure 12: Graphical representation of temperature as a function of depth -PII(20)-Dike body

Figure 13: Graphical representation of temperature as a function of depth -PIII(10)-Dike body

Figure 14: Graphical representation of temperature as a function of depth -PIII(10)-Dike body

In Figs. 11 to 14, we obtained very high correlation coefficients (0.91, 0.90), which explains that there is a very good relationship between the two parameters and that there is stability in temperatures at each depth level. The groundwater flow is uniform and does not change abruptly. They show that there is a good correlation that tells us about the normality and stability of temperatures, thus confirming the absence of leaks and infiltrations in the body of the dike.

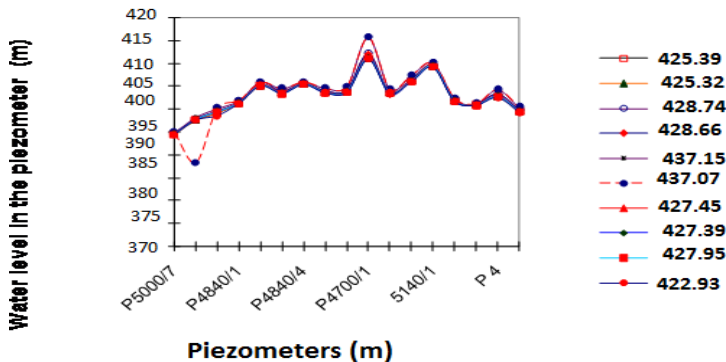
Figure 15: Piezometric variation as a function of lake level – dike body- Ouizert Dam

According to Fig. 15, we note that the curvature of the piezometric lines is small, and the piezometric lines are parallel and confused (liquid sections of the current are flat and the flow varies gradually and not abruptly), which means the presence of low permeable geological layers reflecting the absence of cracks and water leaks in the dam body (Benfetta and Achour, 2017; Heinrich, 2001).
