## ENHANCEMENT OF THE STUDY OF WATER LEAKS ON THE LEFT BANK IN THE OUIZERT ALGERIAN DAM

**BENFETTA H.<sup>1\*</sup>, REMINI B.<sup>2</sup>, ACHOUR B.<sup>3</sup>, OUADJA A.<sup>4</sup>**

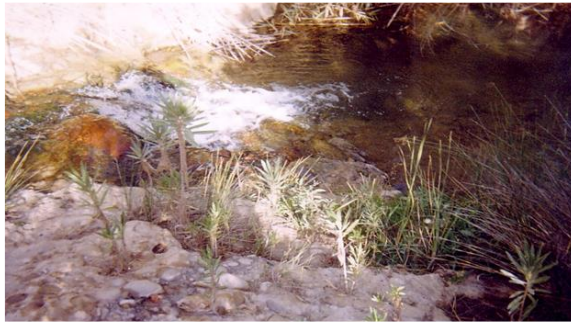
**Photograph 2: Water leaks on the left bank of the Algerian Ouizert Dam. Source: Benfetta, 2021.**

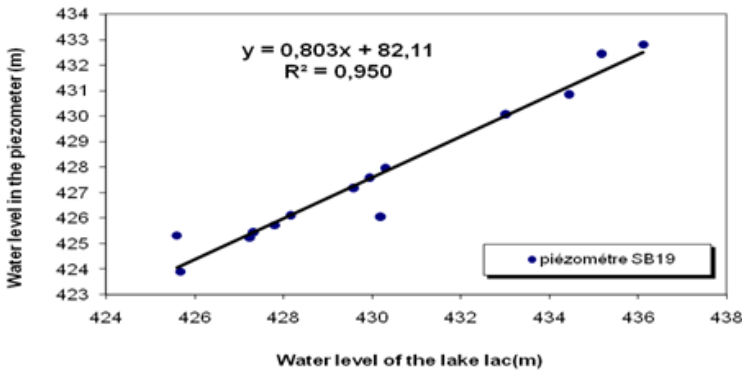
The first part concerned the study of the measured hydraulic parameters and their variation over time, particularly the shores of the lake and the piezometric coasts. Figs. 5 and 6 display the variation in the piezometric coast to the lake coast for all the piezometers on the left bank, specifically SB19 and SB16. They clearly indicate a good correlation between the two parameters studied. In general, an excellent correlation was observed for all piezometers. It is then possible to conclude a strong circulation of water between the different piezometers and the restraint. In addition, the slopes of the lines obtained indicate the condition of the areas between the piezometer and the lake. Indeed, the increase in the slopes of the lines shows a movement of water. This is due either to the driving of the clogging materials by the flow created by the hydraulic load or to the chemical dissolution of the components of the rock mass. On the other hand, the diminution of the slopes indicates a low circulation of water, reflecting the fact that the geological layers are less permeable. In addition, the increase in the slopes of the regression lines for some piezometers indicates some deterioration of the layers crossed by the latter. This deterioration can be explained by the break-in due to water-driven sealing of cracks and splines (Benfetta and Remini, 2008; Benfetta, 2017).

Figure 5: Variation in the water level in the piezometer as a function of the water level of the lake in Piezometer SB19. Source: Benfetta, 2021.

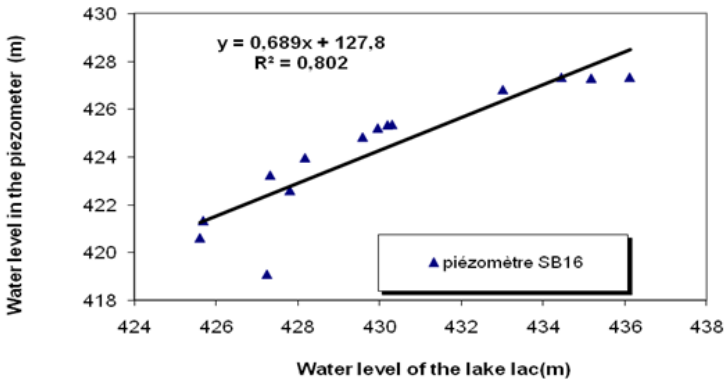
Figure 6: Variation in the water level in the piezometer as a function of the water level of the lake in Piezometer SB16. Source: Benfetta, 2021.

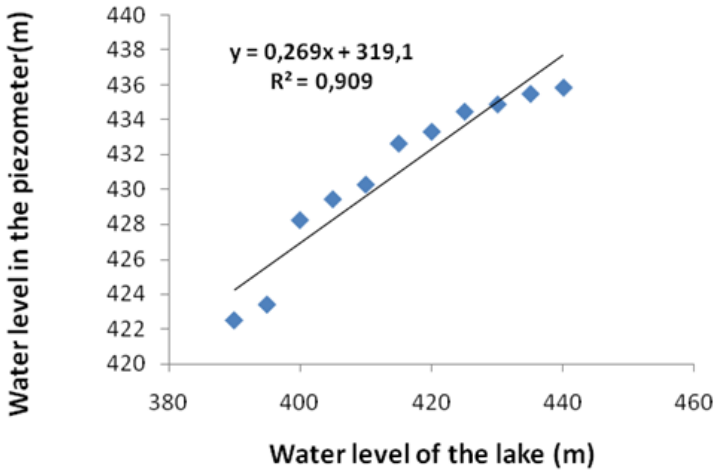
The first part also concerned the chronological evolution of the water coast in the piezometers of the left bank compared to the lake coast during the period from 1989 to 2018. This allowed us to distinguish the destroyed, clogged and unaffected areas. Figs. 7 and 8 show an example of the variation in the piezometric coast in relation to the lake coast for one of the piezometers considered. We can thus see that the parameters studied are linearly dependent, which is also the case for all piezometers. In addition, it was found

that the slopes of the regression lines obtained were amplified over time, which proves a break-up at the level of the geological layers of the left bank crossed by these piezometers. In addition, when the shores of the lake exceeded 430 m, the slopes of the regression lines increased. This means that the higher the shore of the lake is, the greater the circulation of water in the cracks between the lake and the left bank. This has resulted in the relative deterioration of geological layers through internal erosion (Benfetta, 2017; Toumi and Remini, 2004). The variation in the piezometric line, measured at the level of the piezometers on the left bank, for different shores of the lake was also studied in this first part (Fig. 9). The current lines have a strong curvature. Additionally, the groundwater flow is not uniform and abruptly varies. This reveals the presence of cracks that are preferred routes for water leakage on the left bank of the dam (Benfetta and Remini, 2008; Benfetta, 2017).

Figure 7: Evolution of the piezometric coast as a function of the coast lake in piezometer SB13 (Left Bank) for the hydrological year 2016-2017. Source: Benfetta, 2021.

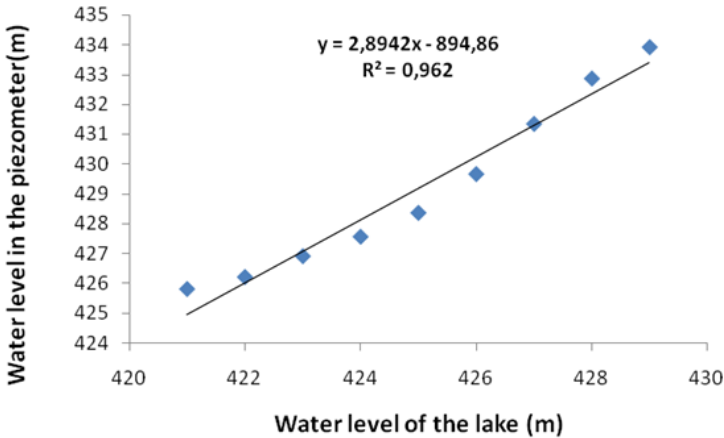
Figure 8: Evolution of the piezometric coast as a function of the coast lake in piezometer SB13 (Left Bank) for hydrological year 2017-2018. Source: Benfetta, 2021.

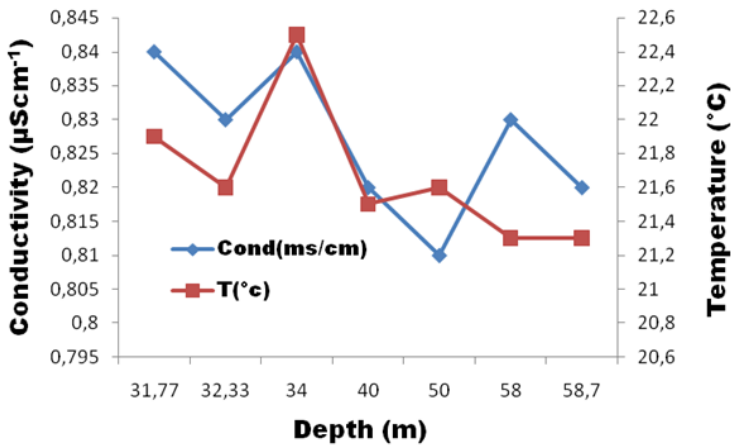
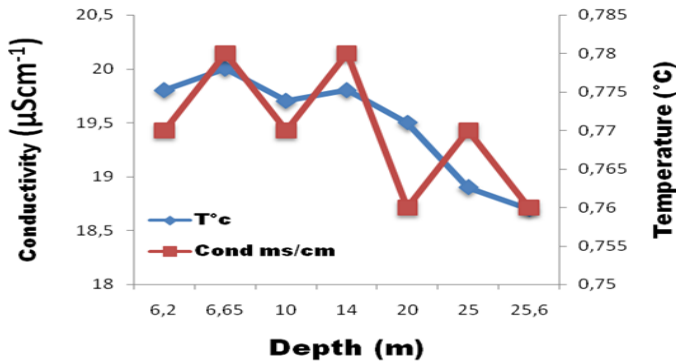
**Figure 10: Conductivity profile combined with temperature in piezometers SB5 and SB13. Source: Benfetta, 2021.**

Fig. 10 illustrates the conductivity profiles combined with the temperature profiles at one of the piezometers considered. Two types of flows were depicted in all profiles: the first is vertical downward, represented by the practically constant values of temperature and conductivity, while the second is oblique and almost horizontal from the lake of the water retention at lower conductivity and homogeneous temperature values. This perfectly reflects the degraded state of the geological layers (Benfetta, 2017; Hocini and Moulla, 2005).

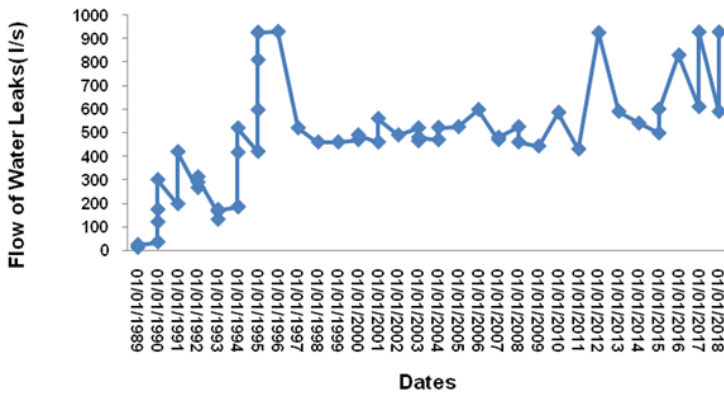
**Figure 11: Variation in time of the water leakage flow of the Ouizert Algerian dam. Source: Benfetta, 2021.**

The third part of the study focused on the analysis of leakage flows while examining their variation both over time (Fig. 11) and in relation to the level of the lake coast for two hydrological years taken as examples (Figs. 12 and 13). A review of Fig. 8 suggests the following (ANBT, 2019):

- The flow of water leaks through the left bank increased almost dramatically from 11.6 l/s as of 05/24/89 to 926 l/s as of 05/07/95.
- Due to the reduction in the volume of water in the reservoir, the flow of leaks through the left bank decreased significantly, reaching a value of 460 l/s at the time of sampling on 11/12/2001.
- As a result of the increase in the volume of water in the reservoir, the flow of leaks through the left bank increased almost gradually from 460 l/s as of 11/12/2001 to 925 l/s as of 08/12/2012. It reached the record value of 940 l/s as of 13/12/2013.
- The flow of leaks through the left bank decreased gradually from 940 l/s as of 13/12/2013 to 590 l/s as of 12/07/2018. This decrease is simply explained by the gradual reduction in the volume of water in the reservoir (Benfetta, 2017; Toumi and Remini, 2004).

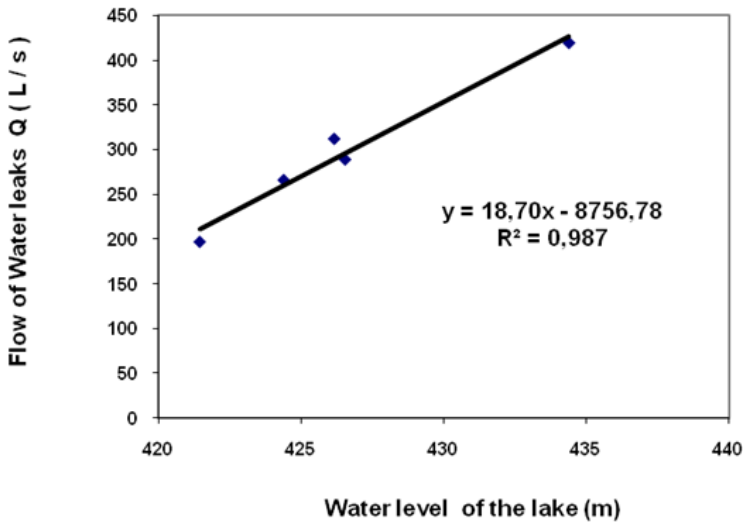
**Figure 12: Variation in water leakage flow as a function of the water lake coast (1994/95). Source: Benfetta, 2021.**

An examination of the leak flow change through the left bank as a function of the water level in the reservoir led to the conclusion that for all the hydrological years considered, the flow of water leaks increased linearly with the water level in the reservoir lake. The high values of the correlation coefficients (0.987 and 0.956) calculated for the two hydrological years 1994/1995 and 2011/2012, respectively (Figs. 12 and 13) show this fact. Additionally, the flow of water leakage gradually increased to 430 m shore, beyond which it rapidly increased. Variations in the flow of water leaks as a function of the water level in the dam lake can be explained by the fact that when the lake's coast is below 430 m, the flow of water leaks is governed by Darcy's law. It then depends on the permeability of the rock. When this coast exceeds 430 m, the underground flow no longer obeys Darcy's law and involves high permeability layers and even faults. To this is added the flow through the splines whose appearance is due to the reduction of the pressure losses from the coast of 430 m. Beyond this coast, measurements confirmed the continuous increase in the flow of water leaks across the left bank of the Ouizert Dam over time. This increase was remarkable for hydrological years 94/95 and 2011/2012. The increase in hydrostatic pressure due to the progressive raising of the water level in the dam lake resulted in a significant decrease in the load loss. This resulted in the deterioration of the rock mass at the dam site, resulting in a larger crack opening (Benfetta, 2017; ANBT, 2019).

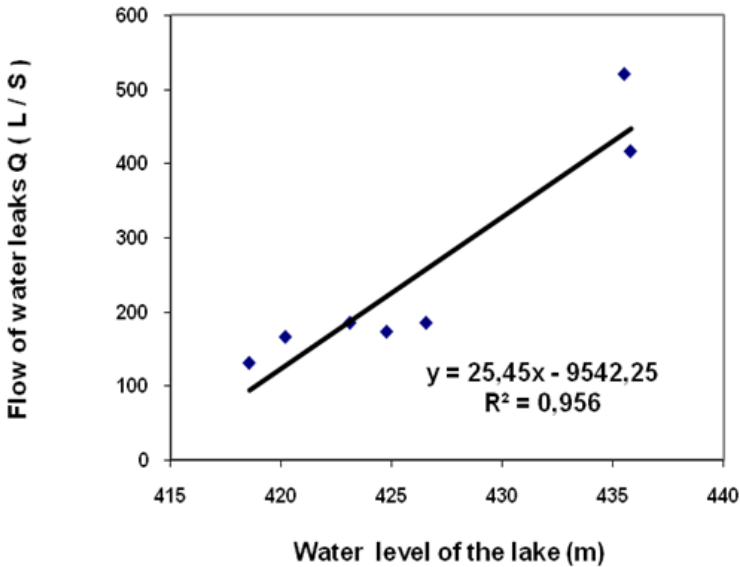
**Figure 13: Variation in water leakage rate by lake coast (2011/2012).** Source: Benfetta, 2021.
