EXPERIMENTAL DESIGN JUSTIFICATION OF THE SHORT-SPAN SPILLWAY'S TAIL-WATER DEVICES

The article examines proposals for ensuring trouble-free and reliable operation of short-span spillway structures, which are widespread in reclamation systems of the Russian agro-industrial complex using the example of the Kursk complex hydroelectric complex. Is given an analysis of the results of hydraulic studies which evaluate the design solution for the devices of the outlet section of the three-span spillway of the hydraulic system that is expanding in terms of plan. Are presented the schemes of technical solutions proposed on the basis of experiments to find rational types of downstream devices that provide effective energy dissipation and prevent the formation of dangerous disruption currents. At the same time, the work of dampers and the entire outlet section was considered under various schemes of alternating open and closed spans of the spillway after its renovation.

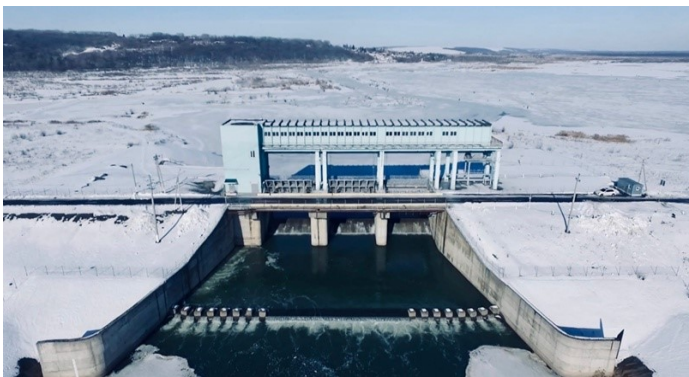
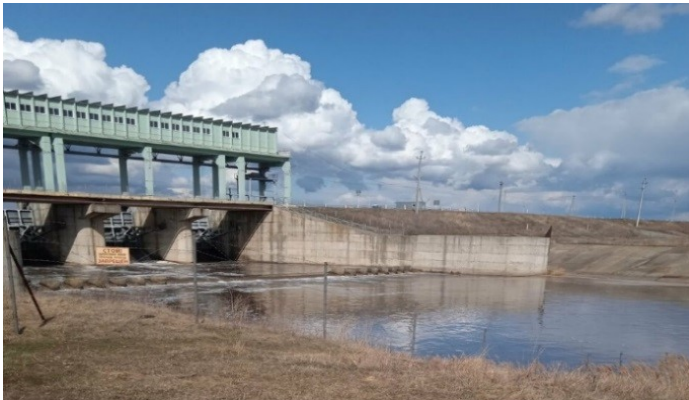
Figure 1: View of the reservoir: a) in winter, 2022 and the outlet section of the three-span spillway dam of the Kursk hydroelectric complex, b) in June 2024.

The spillway was designed in the form of a three-span spillway dam with a threshold of a practical profile, interfaced with the left and right bank parts of the earth dam. Clear span width $b = 12$ m, design spillway flow $Q = 1020$ m³/s, specific flow along the dam = 28.4 m²/s. In the downstream of the spillway, a concrete expanding water well was designed with a depth of 1.3 m and a length of 24.7 m, mating with a short apron 20.5 m long. At the end of the apron there is a bucket partially filled with rock fill. The well and apron have an expansion in plan with a socket angle $\theta = 7^\circ$ to the flow axis. At the base of the spillway lie alluvial deposits, represented by sands of different grains.

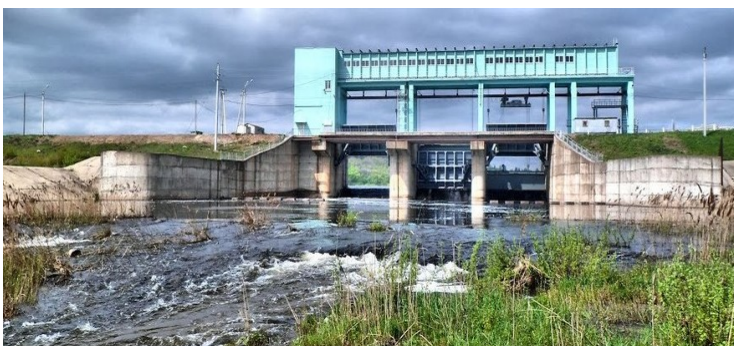
Figure 3: Operation of the constructed spillway of the first stage with two outer spans.

During the construction of the Kursk hydroelectric complex, only the second row of dampers was installed at the end of the water well (Fig. 3).
