## ENHANCEMENT OF THE STUDY OF WATER LEAKS ON THE LEFT BANK IN THE OUIZERT ALGERIAN DAM

**BENFETTA H.<sup>1\*</sup>, REMINI B.<sup>2</sup>, ACHOUR B.<sup>3</sup>, OUADJA A.<sup>4</sup>**

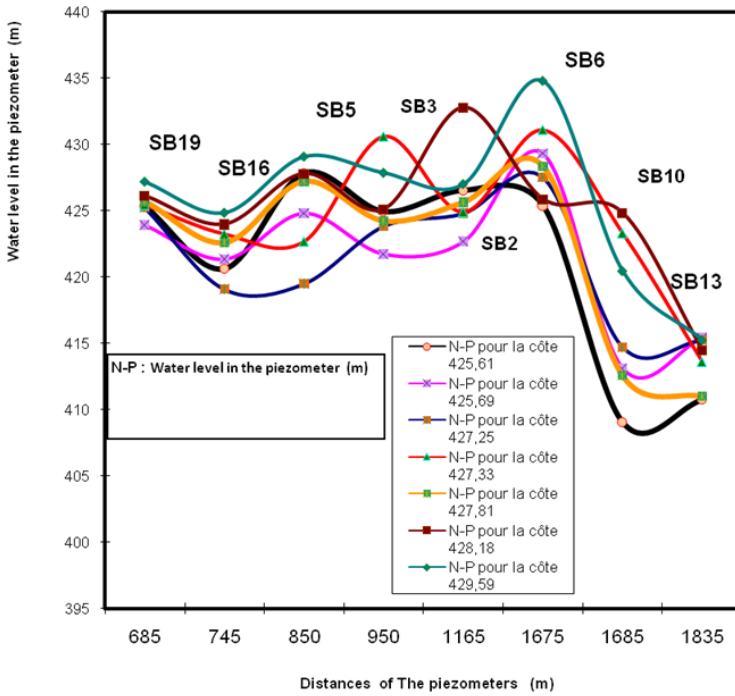
Figure 9: Variation in the piezometric line according to the lake coast of the Algerian dam of Ouizert. Source: Benfetta, 2021.

that the slopes of the regression lines obtained were amplified over time, which proves a break-up at the level of the geological layers of the left bank crossed by these piezometers. In addition, when the shores of the lake exceeded 430 m, the slopes of the regression lines increased. This means that the higher the shore of the lake is, the greater the circulation of water in the cracks between the lake and the left bank. This has resulted in the relative deterioration of geological layers through internal erosion (Benfetta, 2017; Toumi and Remini, 2004). The variation in the piezometric line, measured at the level of the piezometers on the left bank, for different shores of the lake was also studied in this first part (Fig. 9). The current lines have a strong curvature. Additionally, the groundwater flow is not uniform and abruptly varies. This reveals the presence of cracks that are preferred routes for water leakage on the left bank of the dam (Benfetta and Remini, 2008; Benfetta, 2017).
